INGLEBOROUGH

WHAT IS ON THE SUMMIT?

**Arthur Batty and Noel Crack
2009**

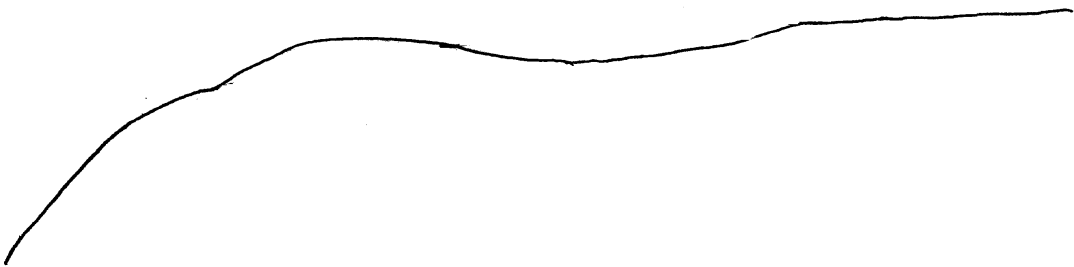
Fig 3: Phases of wall construction where ditch is present.

(a) Showing the original ground surface

(b) Showing area cut away to form false platform

(c) Showing finished construction

(d) Showing remains as they appear today

and outer sides of the WR as it crosses Swine tail, the outer side being lower by approximately 1m (*Plate 1*) thus enhancing the height of the wall and making it more impressive. We suggest that an area covering the whole of the top of Swine Tail has been quarried. A second area is represented by a curving feature on the Northern side, (*Fig 1*) where there is a considerable change in ground level (*Plate 2*), which we think is a quarry face. By projecting a line from the upper edge of this feature out to the edge of the summit a considerable amount of quarried stone would be represented. The third area is the scooped-edge, false platform (*Plate 3*) that runs around the perimeter of the summit, on the internal side of the WR. The false platform starts where the path from Newby and Clapham crosses the WR and travels, initially, in a southwest direction, then turns towards the northwest corner (following the WR) past where the Crina bottom path reaches the summit and, finally, turns east along the northern side to the circular stone remains No 17 at which point it ends. It is no coincidence that the second quarrying area described above is situated at this point, as there is no false platform from the curving feature all the way back to the Clapham entrance. Why is the third quarry area on the line of the WR? It should be considered that, where the false platform is present, the original ground surface of the summit slopes considerably to the edge and required levelling, making this stone immediately available for use in building the wall (*Fig 3 on page 7 opposite*), unlike the rest of the summit where it is flat to the edge. Therefore, no false platform means that an alternative quarry is required.

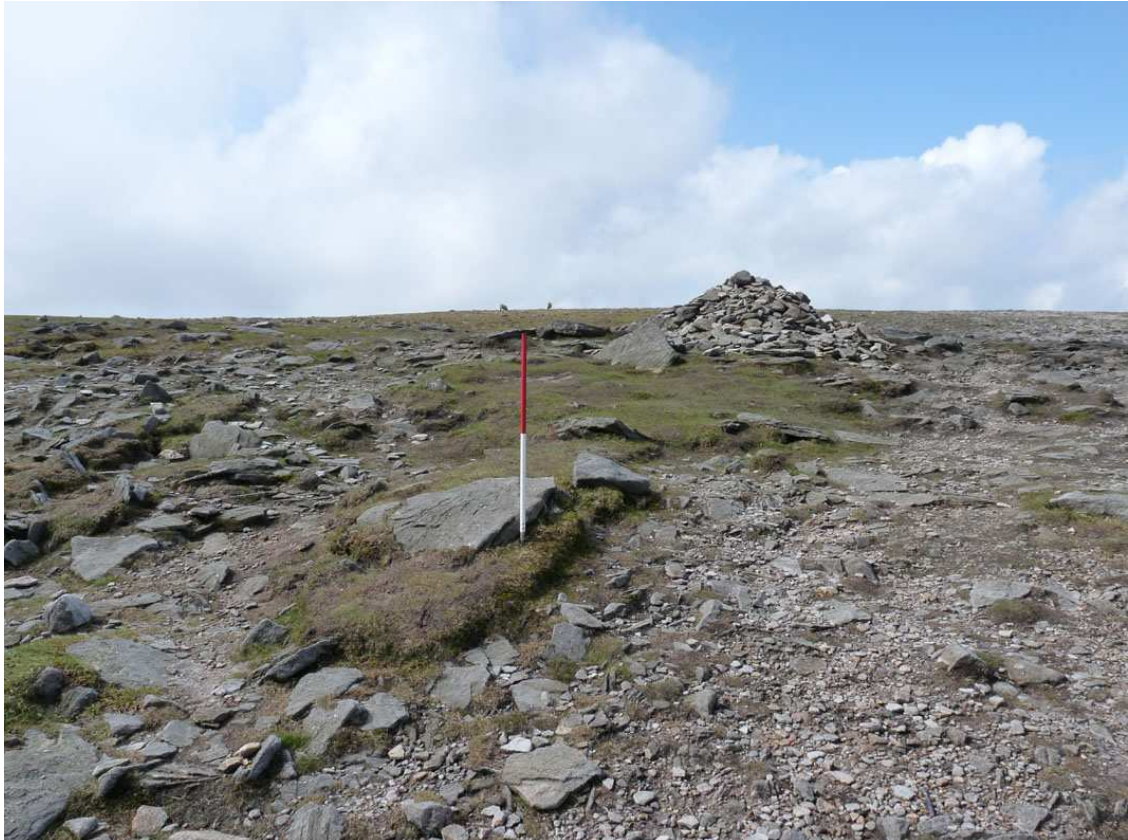
Plate 1: Swine Tail - showing the change in ground level representing the edge of the quarried area. Looking towards the summit see Fig 8.

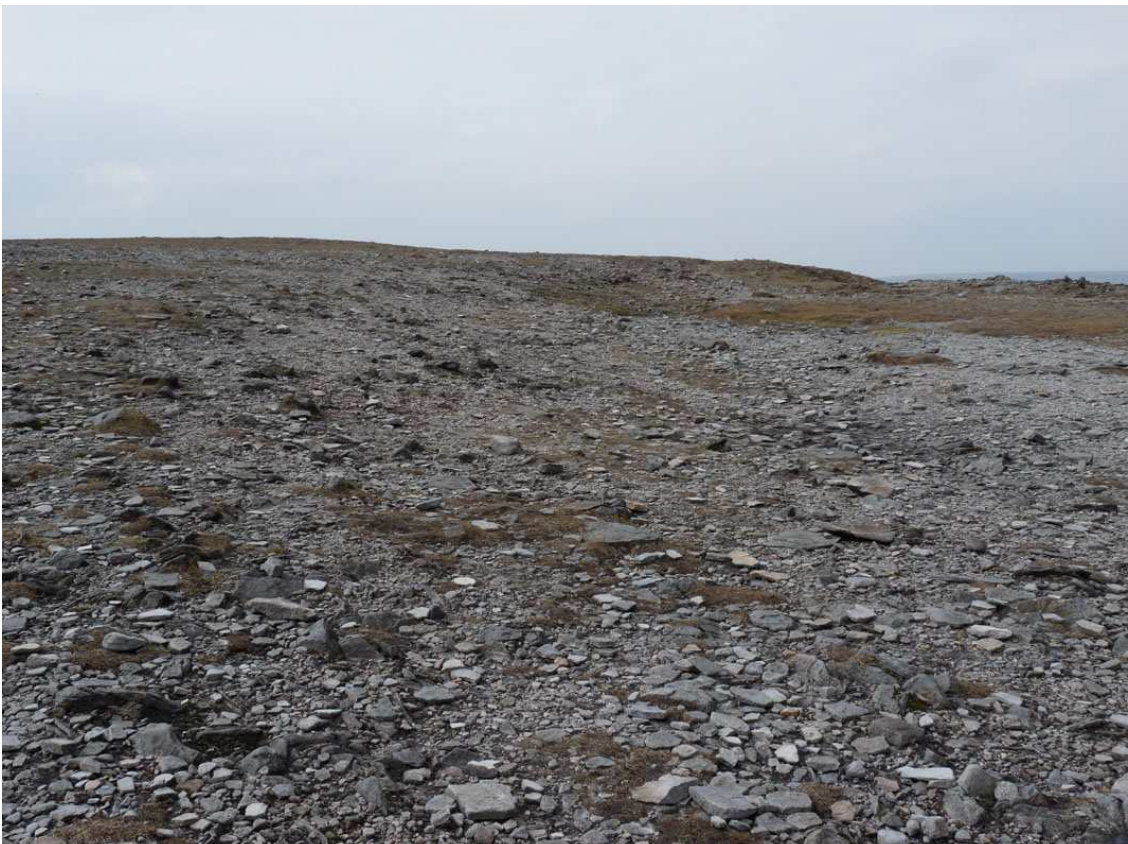
Plate 2: Showing the curving edge of the quarried area on the northern side of the summit (Fig 8).

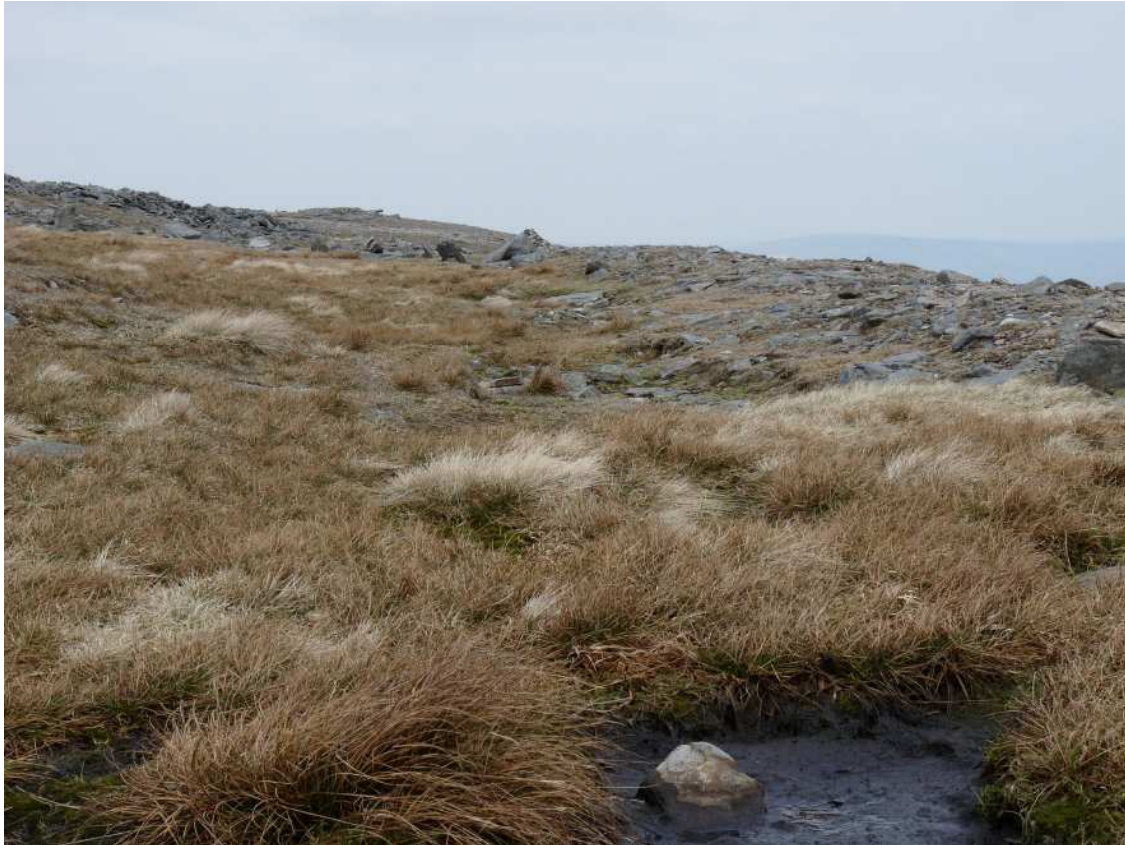
Plate 3: The scooped-edged false platform on south-eastern side showing build up of peat at the rear of the wall (Fig 8).

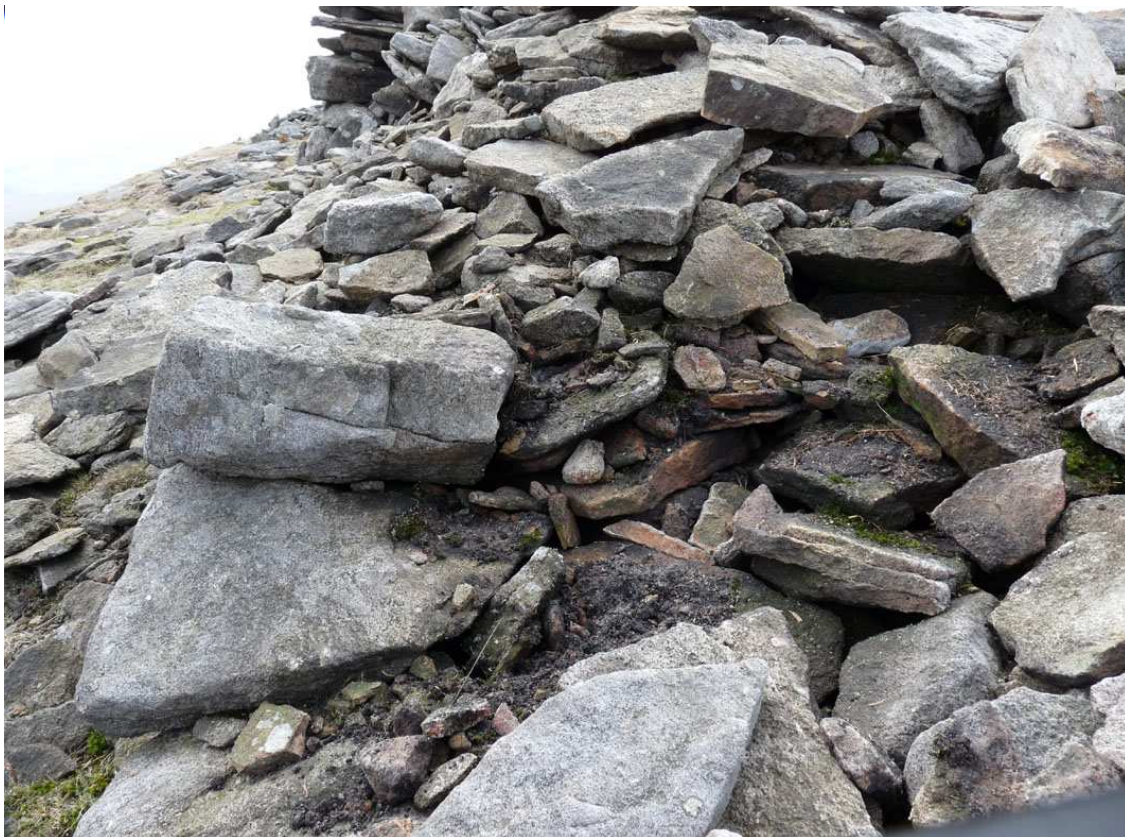
Plate 4: The photograph, taken on the eastern side of the summit, shows that there is no internal face to wall, but the infill can clearly be seen abutting the outside face.

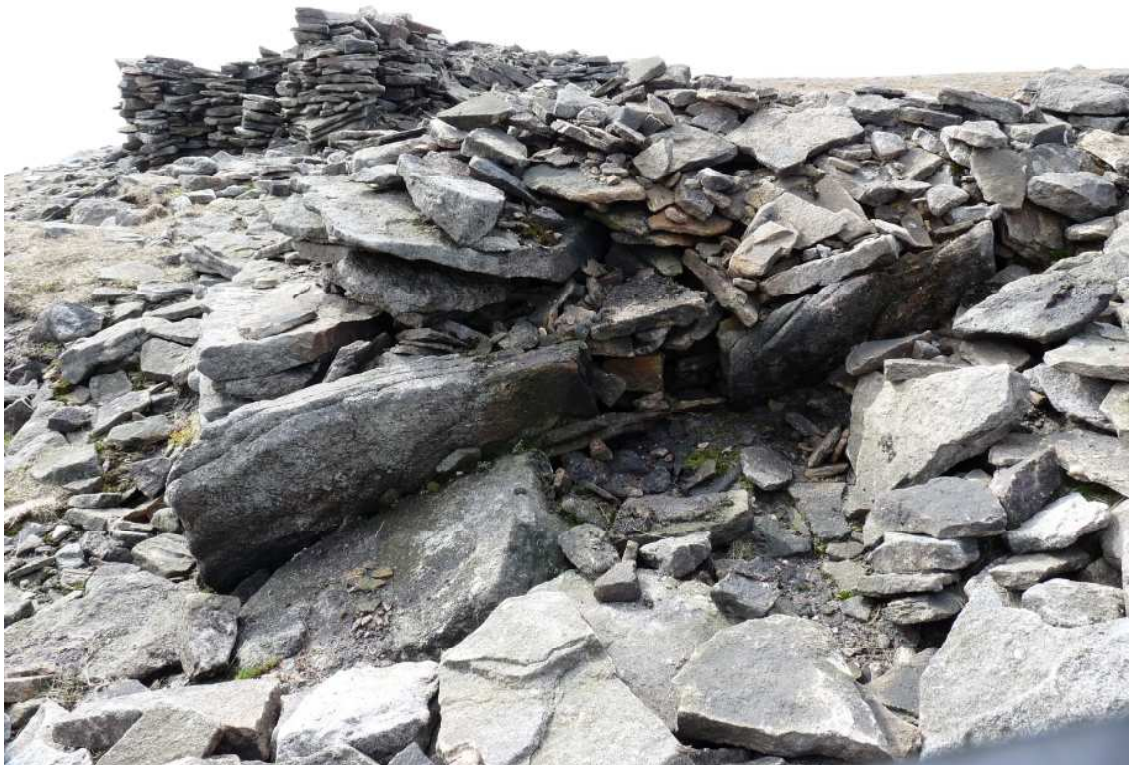
Plate 5: Orthostats forming the box sectioning of part of the wall on the north-east side of the summit.

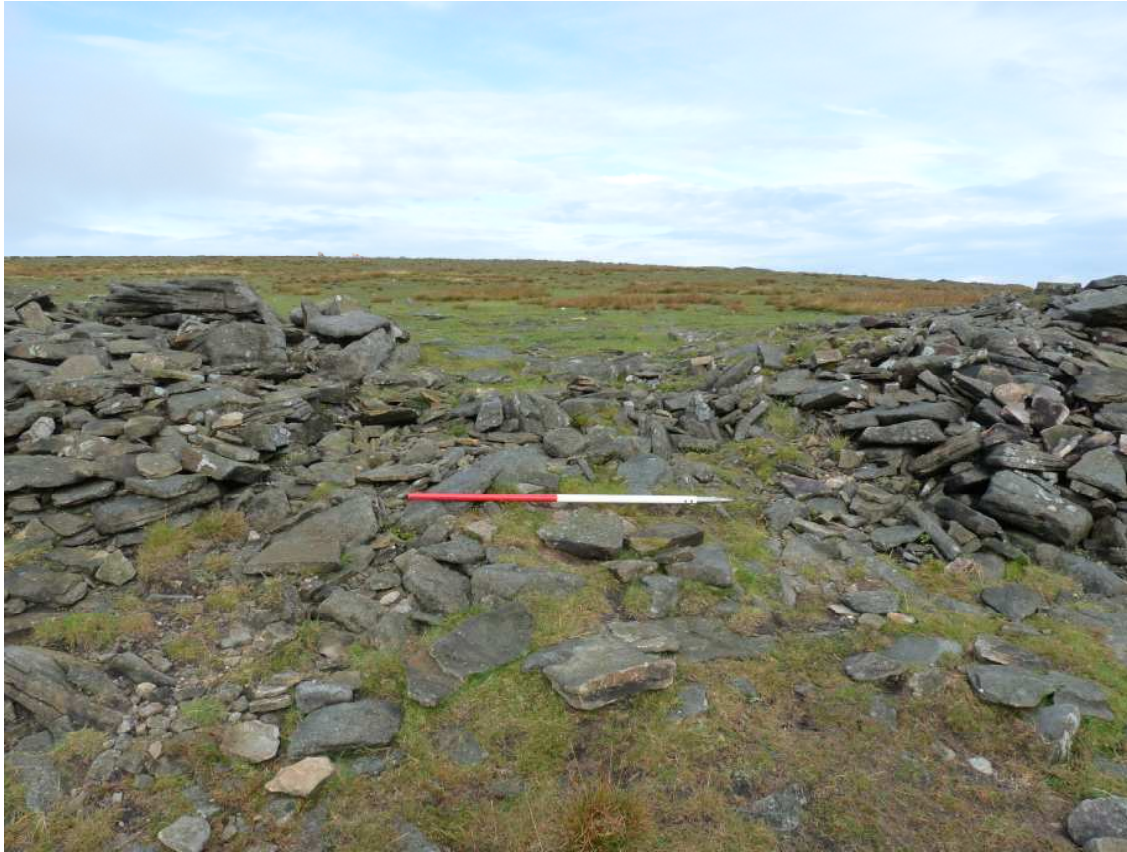
Plate 7: Showing foundation stones on either side of the entrance on south-east side of summit.

A 1.5m wide gap between the wall foundation stones on the SE side is convincing evidence for an entrance, due to the presence of foundation stones on either side of the gap, running at right angles to the WR (Plate 7). There is a 20m long section on the SW side where no quarrying has taken place on the wall line (Plate 8) this could possibly be an entrance. However, there are other gaps in the WR but these have no convincing evidence of being entrances as there are no remaining foundation stones to be seen running at right angles to the main wall.

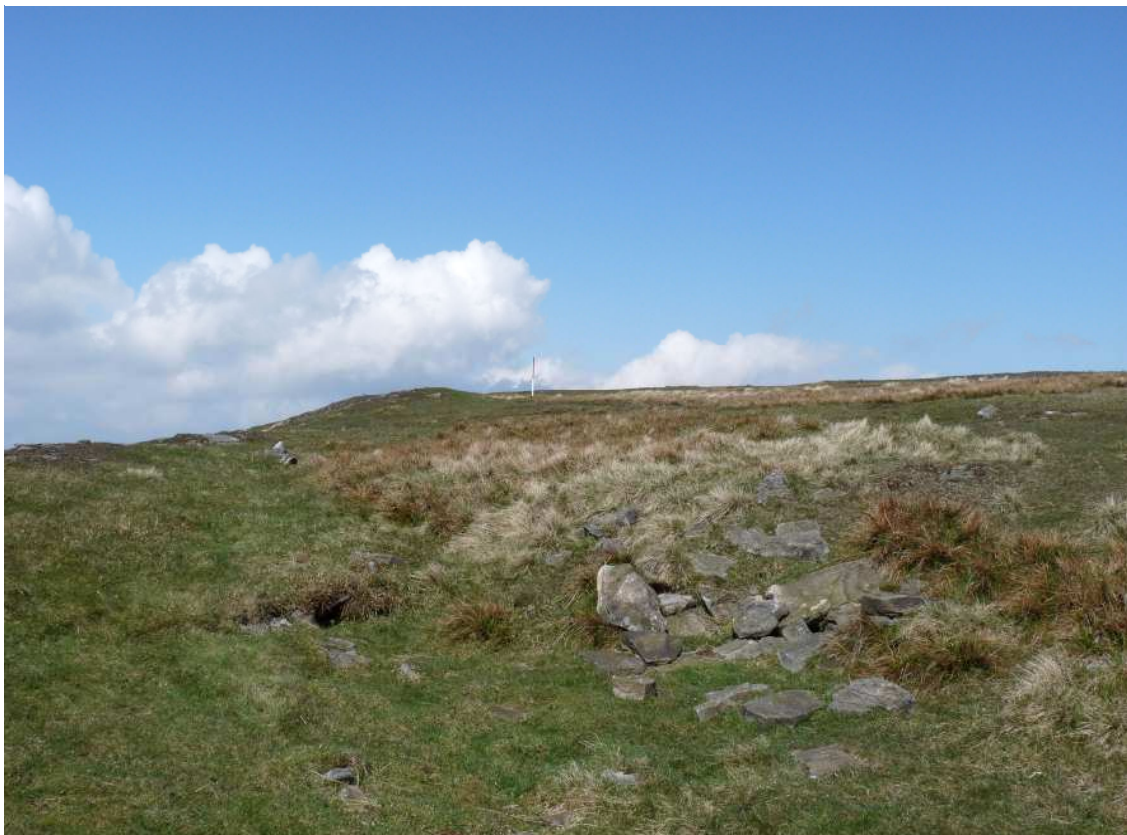
Plate 8: On the south-west side where no false platform has been created. The stones in the foreground shows the edge of the quarrying.

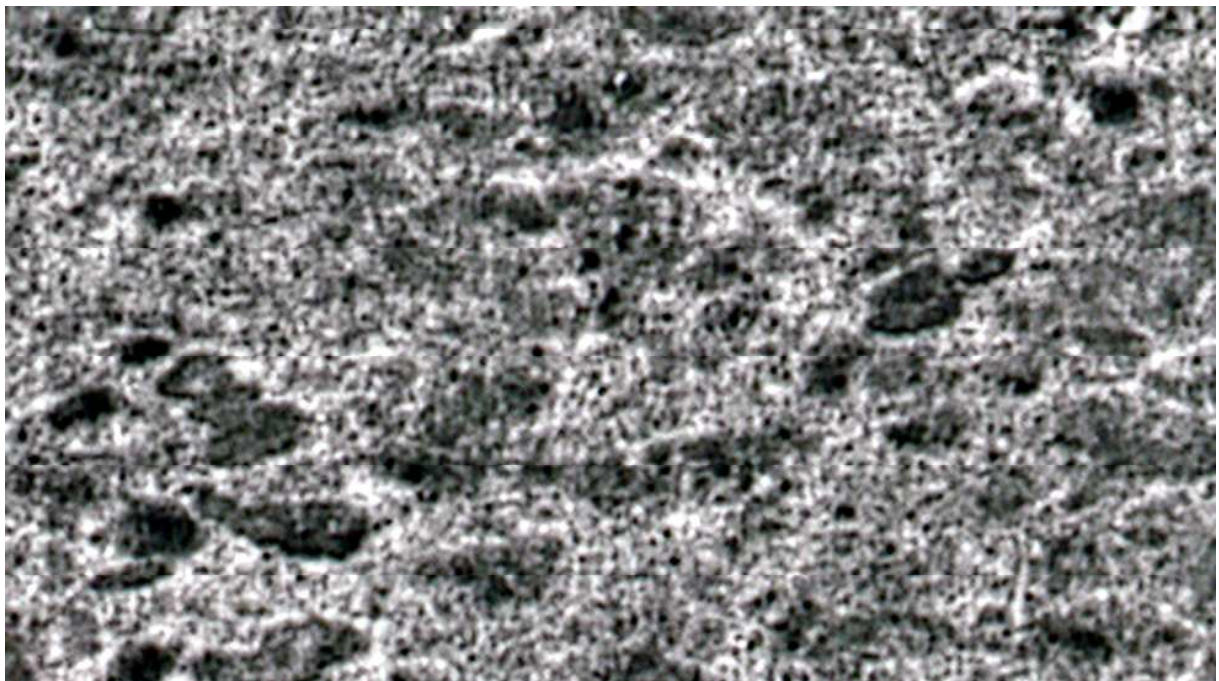
Plate 17: Aerial photograph showing stone circle 27. The curving lighter feature in the centre shows the proposed drip channel.

This is shown by evidence for a drip channel (*Plate 17*).
